# ORBITER TILE IMPACT TESTING

Final Report

SwRI Project No. 18-7503-005

NASA  
Johnson Space Center  
Houston, Texas

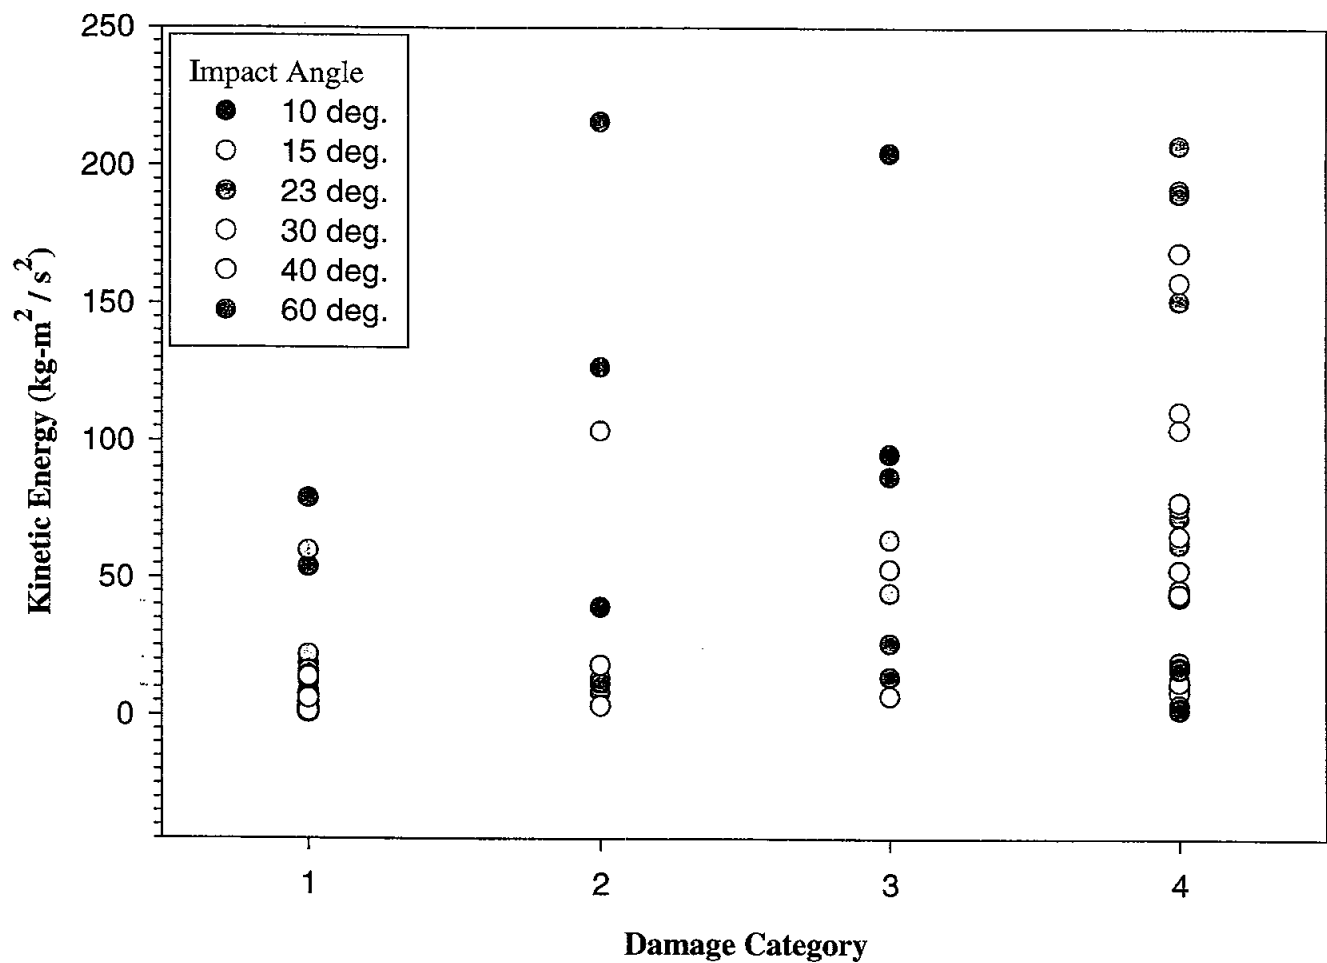
**Figure No. 8: Projectile Kinetic Energy vs. Damage Category**

Figure No. 8 is a plot of the resulting tile damage level or category (1 – No Damage, 2 – Cracking and Delamination of the Coating, 3 – Shallow Crater, 4 – Crater) as a function of the foam projectile kinetic energy. The plot shows a general trend where the level of damage (category) increases as kinetic energy and/or incidence angle are increased. As the incidence angle reaches 60 degrees, projectiles with relatively low kinetic energy (3/8" diameter projectile in this case) can inflict high levels of damage on the tile target.

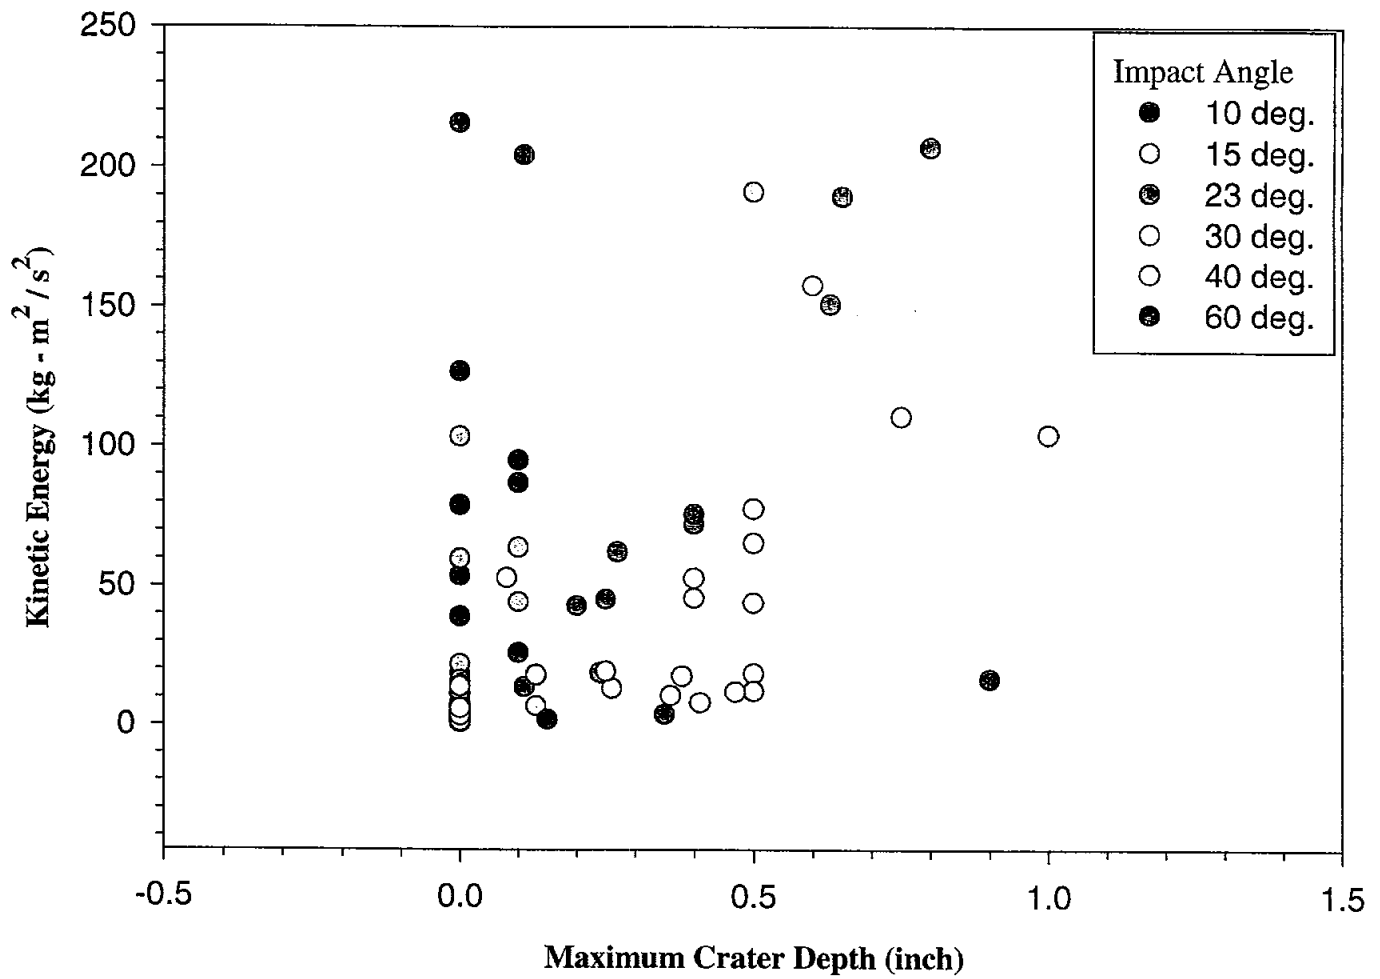
**Figure No. 9: Projectile Kinetic Energy vs. Max. Crater Depth**

Figure No. 9 is a plot of maximum crater depth as a function of projectile kinetic energy. In general, as the incidence angle of impact is increased, crater depth increases. For a given incidence angle, crater depth increases as kinetic energy increases.

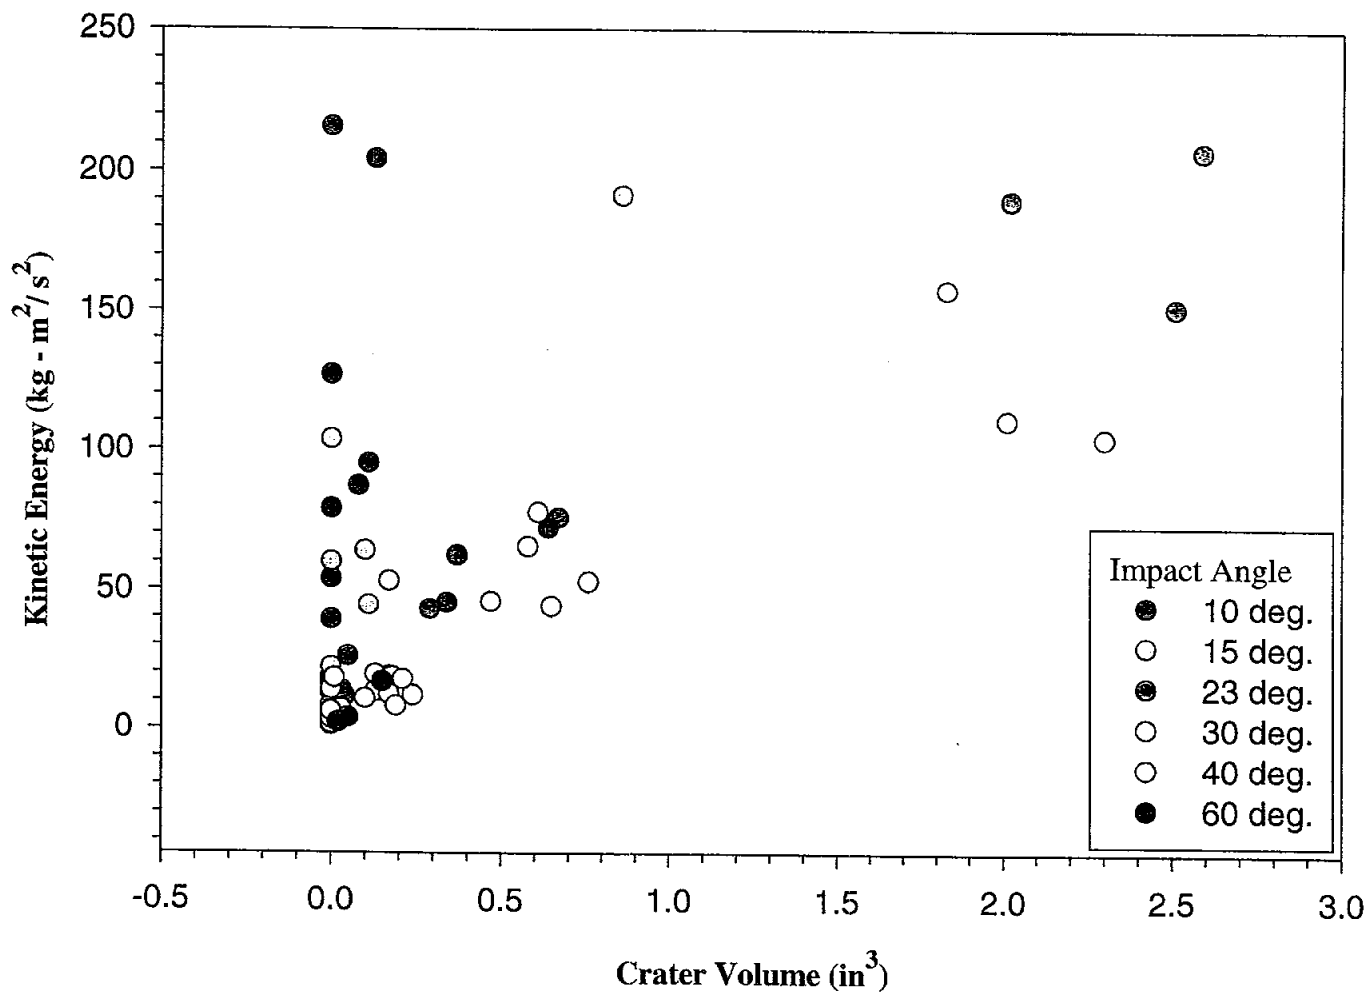
**Figure No. 10: Projectile Kinetic Energy vs. Crater Volume**

Figure No. 10 is a plot of crater volume as function of projectile kinetic energy. In general, crater volume increases as the incidence angle and/or kinetic energy are increased. As expected, tests conducted with large fast moving projectiles fired at increased incidence angles produced the largest crater volumes. Note that in several tests, the crater extended to the edge of the tile target. Thus the total possible crater volume could not be determined. Such tests are labeled with a "\*\*\*" symbol in the damage dimension column of the results tables. The data point for Test No. 60 in which the 1" x 1" x 3" projectile was launched at a 40 degree angle at 1432 fps is not included in the plot of Figure No. 10. The damage was too extensive to accurately measure volume.
